Title: Product weathertightness testing of a sample of Gebrik Walling

Report No: N950-11-16439

Client: Isosystems, Malmedyer Weg, 62, B-4770 AMEL/SCHOPPEN

Issue date: 10 November 2011

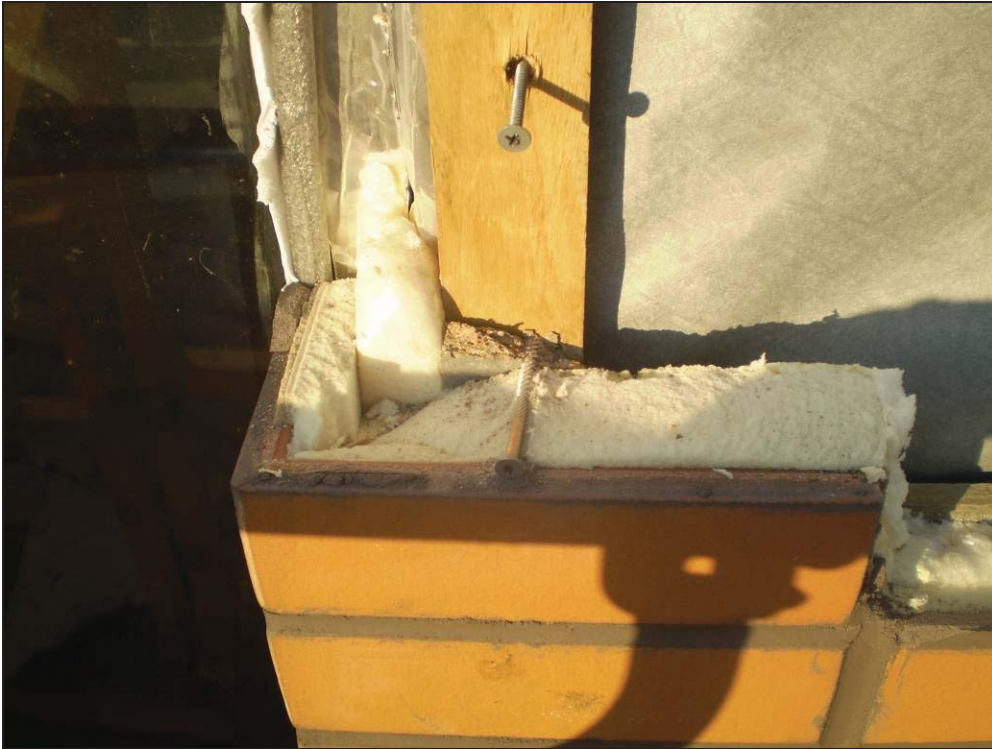
PHOTO 9300028

During the dismantling of the sample no water penetration or discrepancies from the drawings were found in the Gebrik system. At the base of the sample a small quantity of foam sealant had been applied in a couple of locations where water had been observed.

CORNER DETAIL

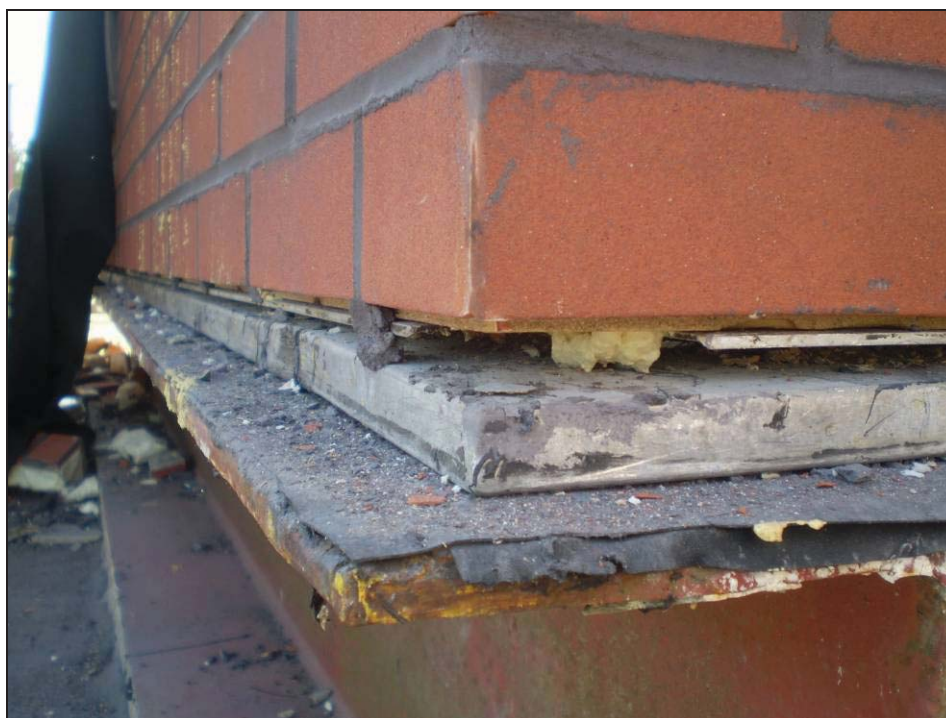
PHOTO 9300054

CORNER VIEW AT BASE OF SAMPLE

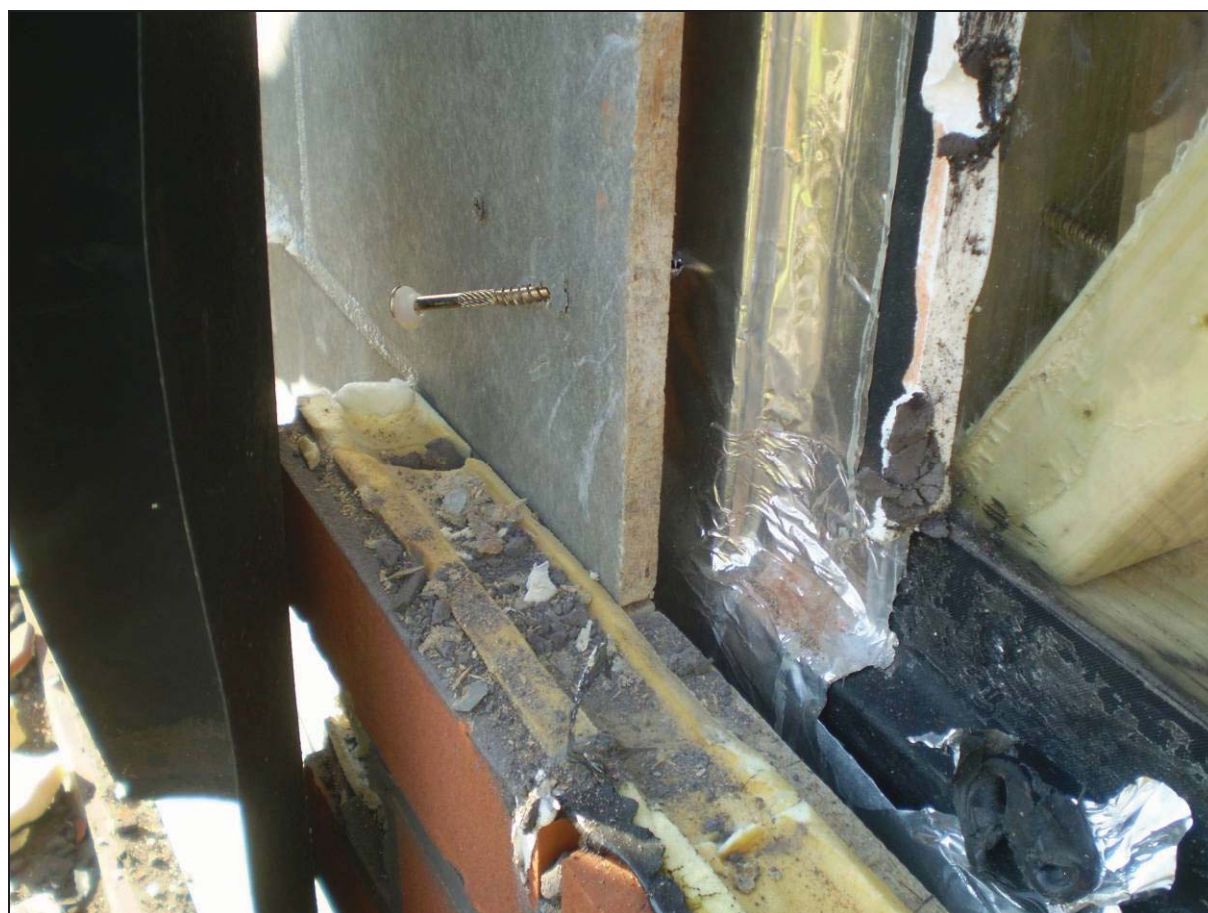
PHOTO 9300056

BOTTOM CORNER DRAIN AT PERIMETER OF WINDOW OPENING

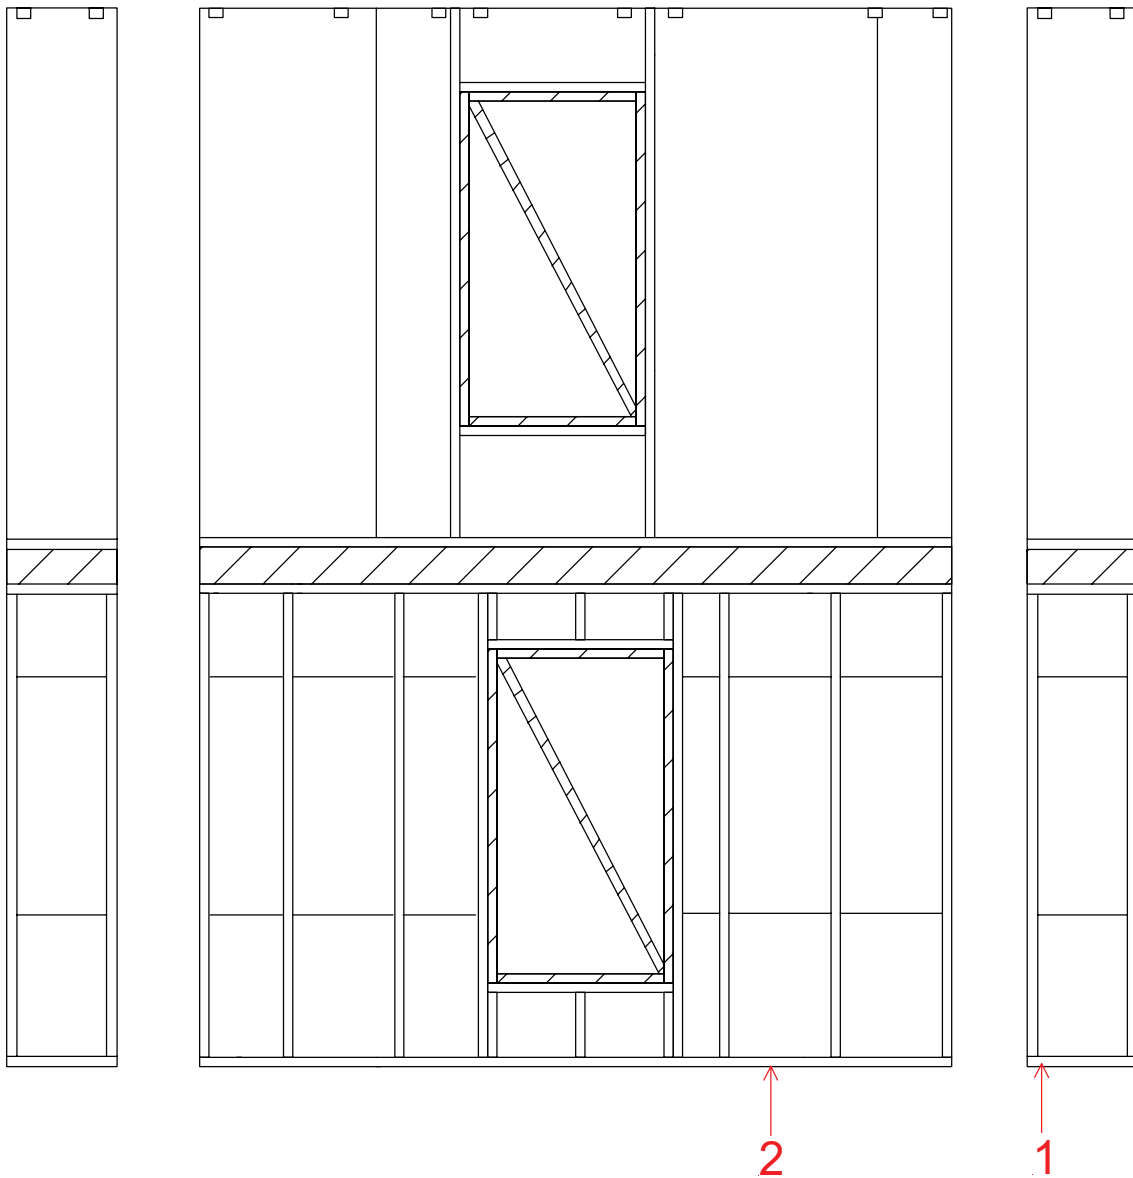
FIGURE 5

After 1 minute at a pressure differential of 450 pascals, water was observed at the base of from a redundant fixing hole in the base of the Metsec frame at location 1 in Figure 5.

After 4 minutes at a pressure differential of 600 pascals water was also observed ponding from a joint in the bottom the Metsec frame at location 2 in Figure 5.

Note: These leaks were not through the Gebrik system but the base perimeter seal to the test chamber. The base support steelwork projected passed the front face of the Gebrik allowing water to pool along the base and was not as shown in the drawings attached to the appendix.

After 1 minute at a pressure differential of 600 pascals water was observed ponding in the base of the return at location 1 in Figure 5.

Note: This leak was not through the Gebrik system but the base perimeter seal to the test chamber.

WATER LEAKAGE LOCATIONS

The hole was sealed over in location 1 and the joint in the Metsec frame sealed over in location 2. Additional foam sealant was applied at the base of the sample at these locations only.

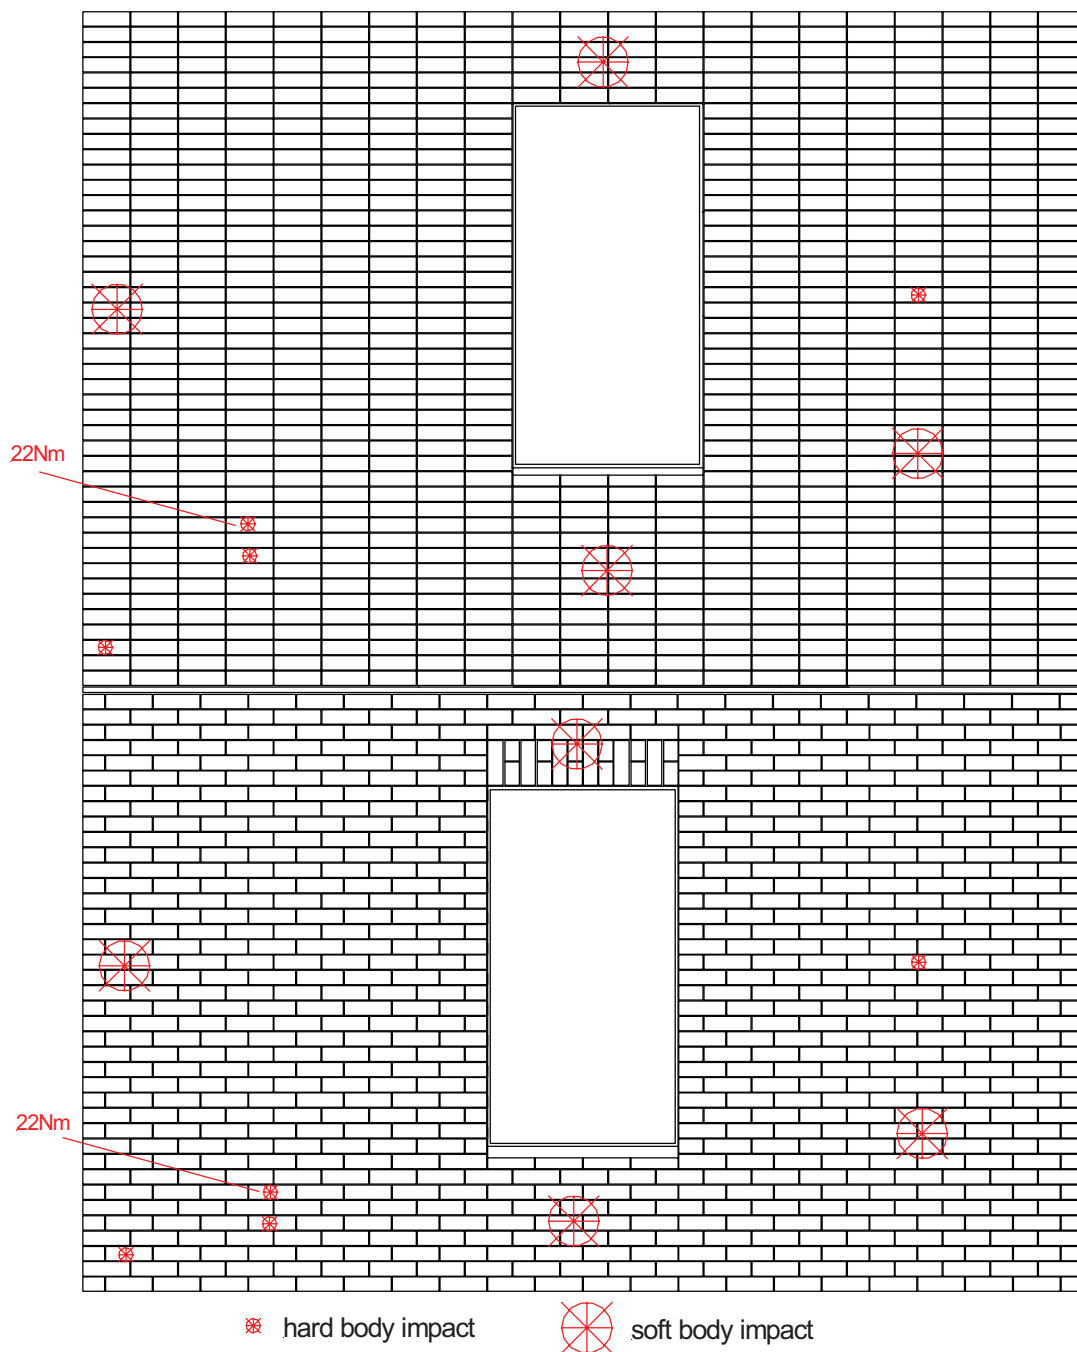
IMPACT TEST LOCATIONS

During the soft body impact testing, with a serviceability energy of 120 Nm, no damage to the sample was observed.

hours prior to testing and was not fully cured). There were also minor cracks in the mortar joints next to the impacts.

During the hard body impacts, including two at 22 Nm energies, no damage to the sample was observed.

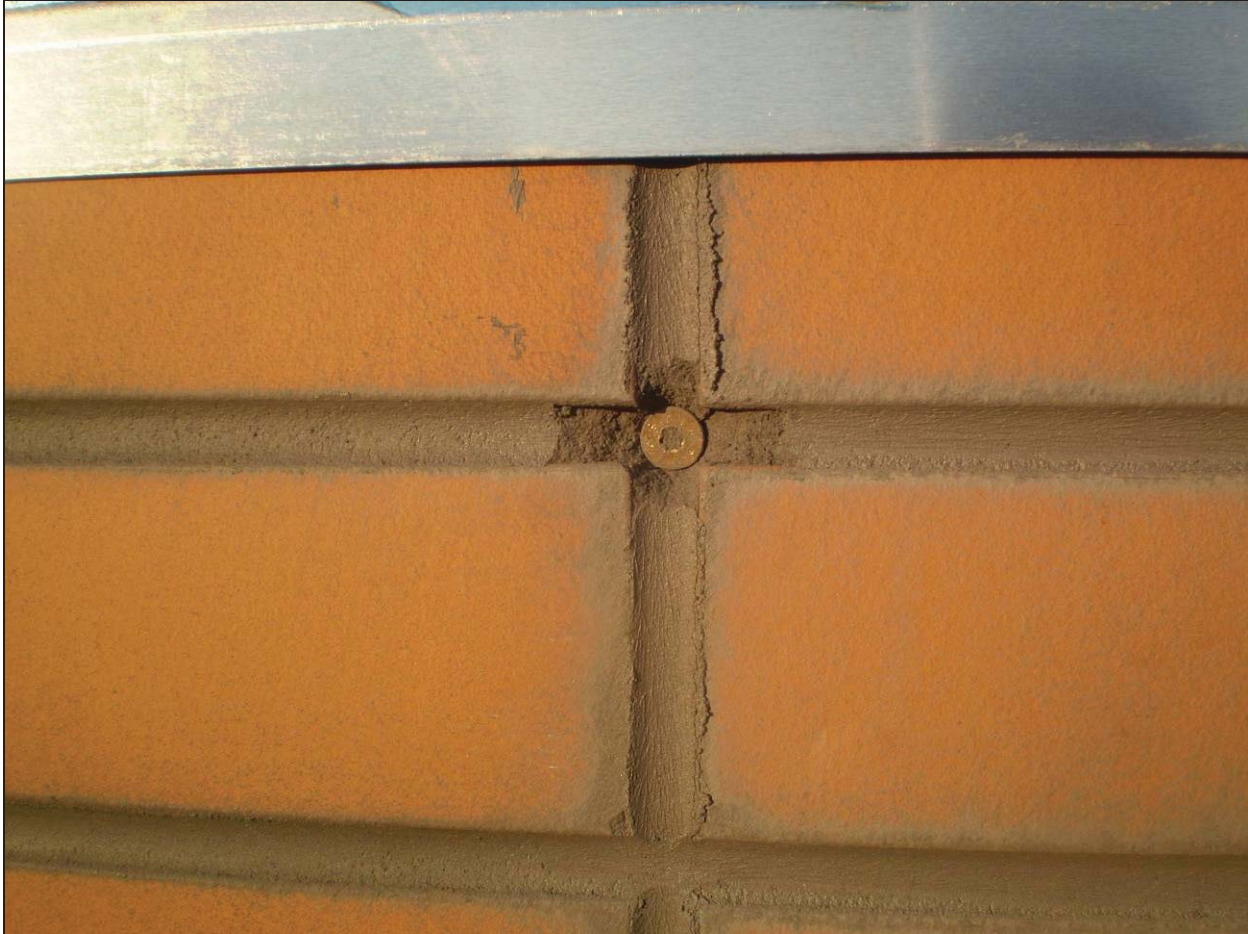
PHOTO 930032

GEBRIK FIXING SCREW REVEALED AFTER 500 NM IMPACT
