## APPLICATION STORY

## Mastering the Maintenance Process: Thermography makes Eaton Group save a quarter of a million dollars per year

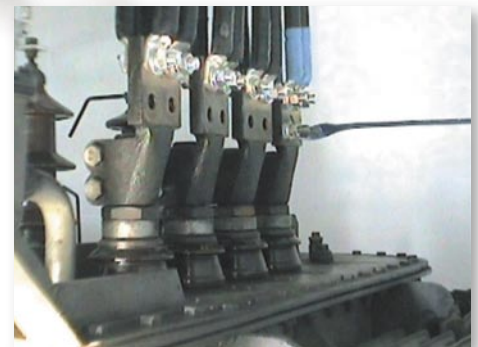
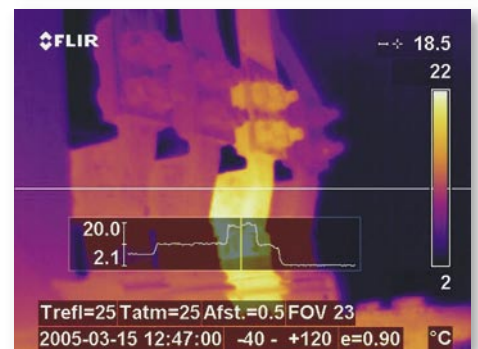
Top of transformer; low-voltage connection

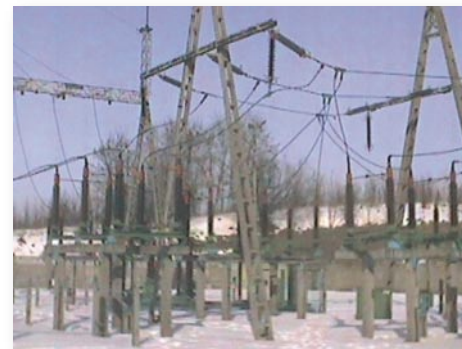
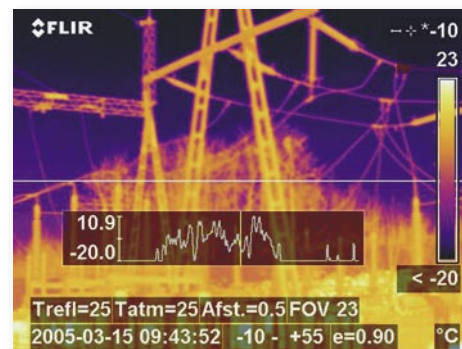
150 KV station, visual and thermal images

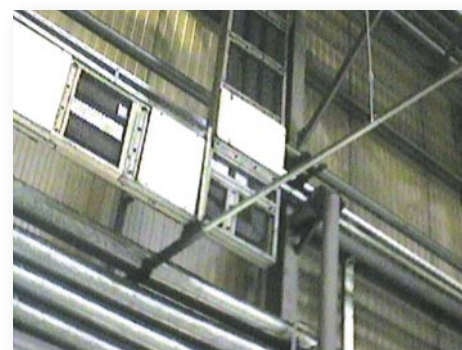
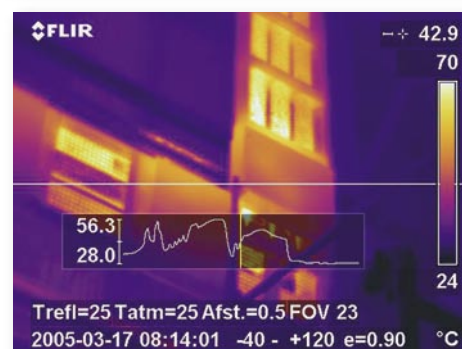
Busbar rail system in production hall
