Thermal imaging helps Globus Baumarkt identify insulation problems

APPLICATION STORY

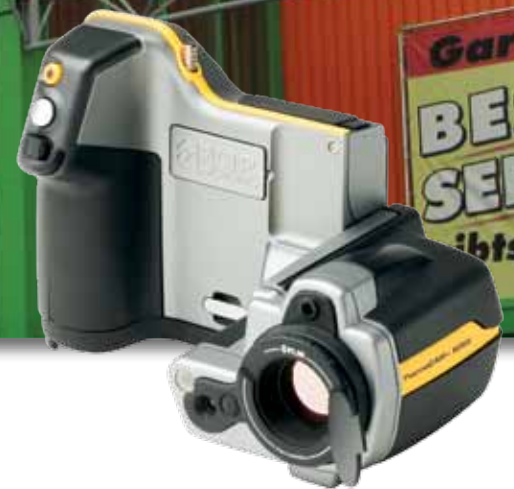
The B365 is smart, compact and powerful; a perfect tool for building inspection.

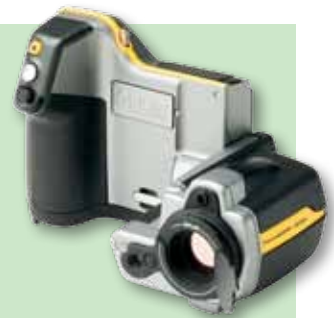
Globus Baumarkt have both the FLIR B335 and the FLIR B365 thermal imaging cameras. The B-Series of portable thermal imaging cameras take ergonomics, weight and ease-of-use to a new level. Usability is key: FLIR has translated user feedback on comfort and clarity into a series of thermal imaging cameras that have comprehensive and innovative features, specially designed for building environments. The FLIR B335 and the FLIR B365 share the following features:

320x240 pixel resolution

Temperature range -20° C to 120° C

<50 mK sensitivity

Picture-in-picture

Humidity and insulation alarm

3.5" LCD touch screen

Integrated 3.1 Mpixel digital camera

Bluetooth connectivity with FLIR Meterlink™
