**More than 400,000 € saved at Heathrow airport with the help of a FLIR Systems infrared camera**  
 Heathrow, an airport of the British Airport Authority, is saving money thanks to FLIR Systems infrared cameras.

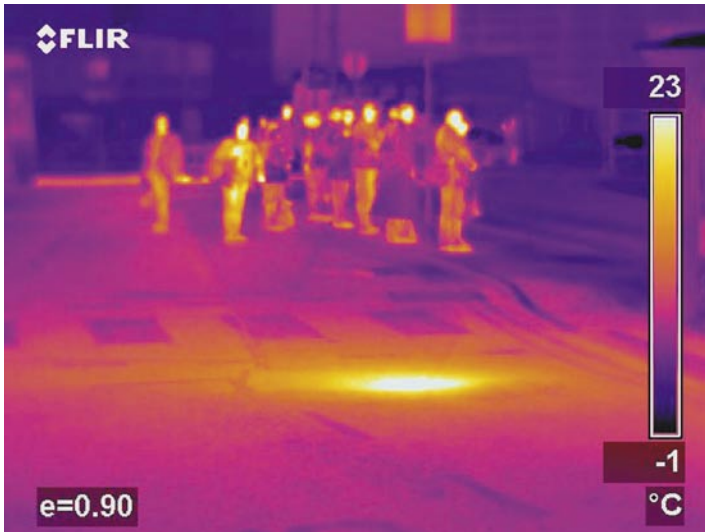
The leak in the pipeline can be clearly located thanks to infrared.

"But the best thing is that the cameras already have paid themselves back before we even started the infrared program.", continues Andy Watson. "We have quite some underground pipelines, which are transporting steam to heat up buildings. It was clear that there was a leak in one of the pipes.

This pipe was located very close to Terminal 1, under a very busy road. We saw steam coming out of 2 inspection pits in the road so we knew that the leak was situated between these 2

pits. Unfortunately they were lying more than 60 meters away from each other, in a very busy road, and we could not see the exact location. I took out the infrared camera and determined the exact location of the leak within seconds."

"Thanks to the FLIR Systems infrared camera, we now only need to break the road open where the pipe is leaking and not over the total 60 meters. We estimated that breaking open and repairing the whole surface to locate and find the leak would have costed us more than 450.000€.
