# Infrared Thermography at largest offshore Intel plant: Intel Malaysia

### INFRARED THERMOGRAPHY AT INTEL MALAYSIA

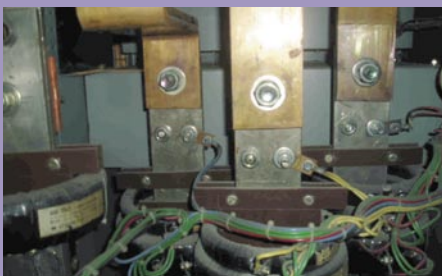
BURNT WIRE FOR POWER METER AND VOLTAGE & AMP METER

Emissivity	0.60
Object Distance	0.5m
Ambient Temperature	22.8°C
Label <b>AR01</b> *	Value <b>max 163.6°C</b>

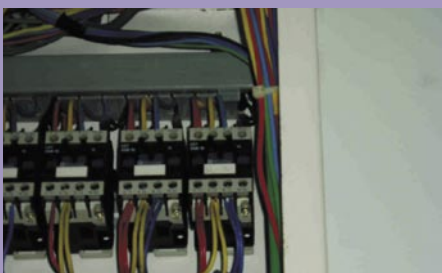
LOOSE CONNECTION CAUSED HEAT BUILD UP IN LIGHTING CONTACTOR

Emissivity	0.97
Object Distance	0.7m
Ambient Temperature	22.8°C
Label <b>SP01</b> <b>SP02</b>	Value <b>97.7°C</b> <b>55.0°C</b>

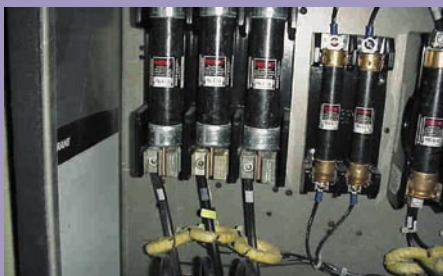
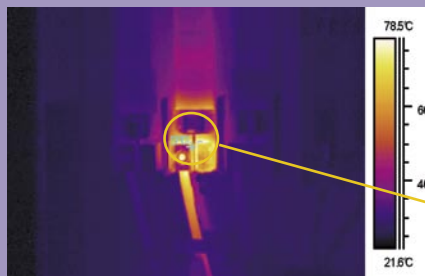
### OVERHEATING CAUSED BY LOOSE FUSE BLOCK CONNECTION

Emissivity	0.80
Object Distance	0.8m
Ambient Temperature	25.0°C
Label	Value
SP01	76.0°C
SP02	31.4°C

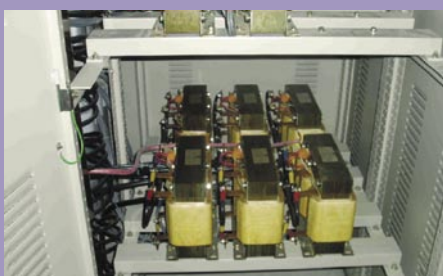
### HUMMING SOUNDS AT REACTOR FOR CAPACITOR BANK DUE TO UNMATCHED OF CAPACITOR VOLTAGE RATING 525V VS 440V

Emissivity	0.95
Object Distance	1.0m
Ambient Temperature	22.8°C
Label	Value
SP01	180.0°C
SP02	94.7°C
AR01 :	max 183.2°C
