APPLICATION STORY

Infrared camera prevents production losses at Parengo paper factory

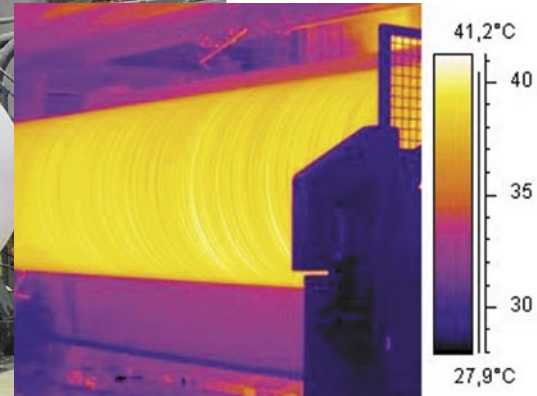
Inspection of the moisture distribution in the paper web shooting past at a speed of approx. 1600 metres per minute.

reduced by drying and pressing from 1% consistency in the head box to a moisture content of 8% on the rewinder. Many parameters affect the drying process. An up-to-date moisture profile thus tells us a lot about the quality of the drying (and hence about the quality of the end product). The infrared camera gives a good picture of the moisture distribution in the paper web, shooting past at a speed of approx. 1600 metres per minute.
