Thermal imaging helps to detect water ingress in airplanes

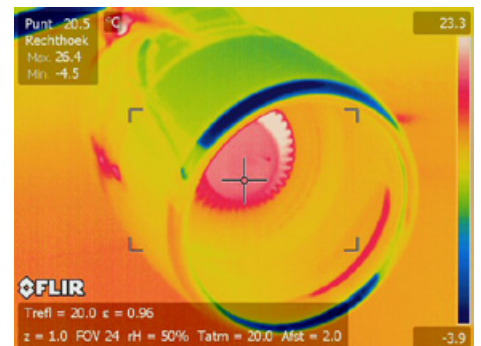
Thermal image of an engine; It takes expertise to "read" the thermal pictures of an airplane as different materials have different emissivity, resulting in different colors in the thermal image.

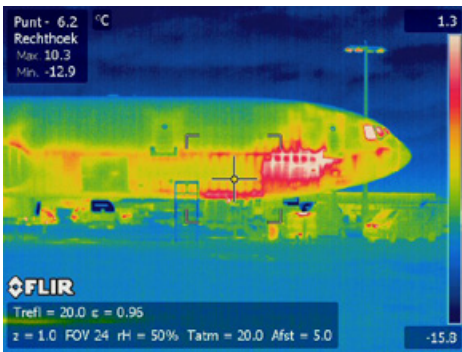
By making a thermal image from a distance you can get a good overview of the entire airplane.
