Thermal imaging helps the Berlin Water Company to provide a continuous service

'We simply cannot afford down-time'

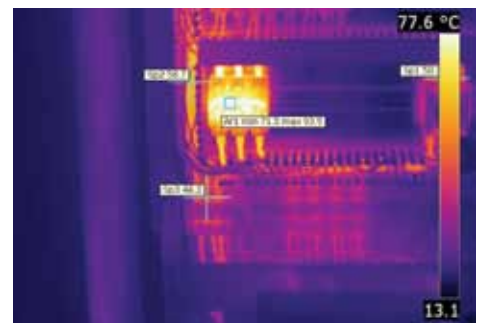
The fuses that show up in the thermal image are overloaded and need to be replaced.

Krämer and his colleagues use the FLIR P620 thermal imaging camera mainly to monitor the electronic equipment like switchgears, connectors, transformers, electrical cables, fuse panels and electrical cabinets. "You can immediately spot where the problem is, because faulty electronic equipment shows up very clearly as a hot spot in the thermal image."

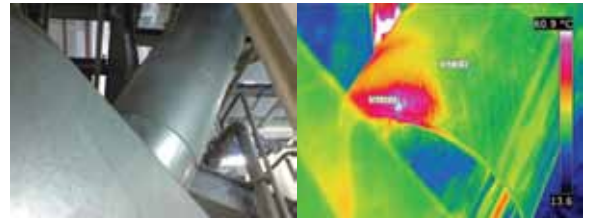
The hotspot in the thermal image shows that this hot steam pipe has either a small leak or faulty isolation.

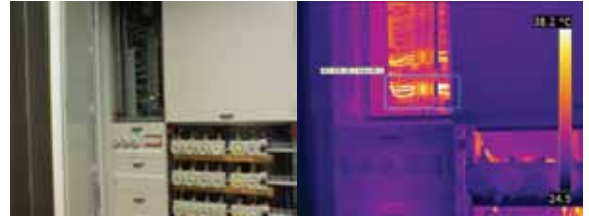
Although these output terminals are definitely hot, the measured temperatures are normal for this kind of load.

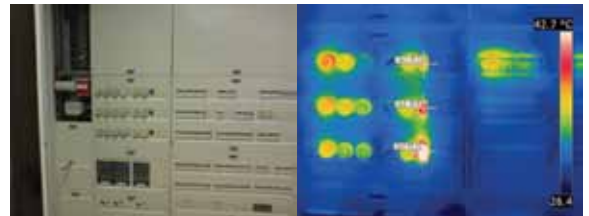
This thermal image shows that the work load during operation is not distributed evenly among the fuse boxes.

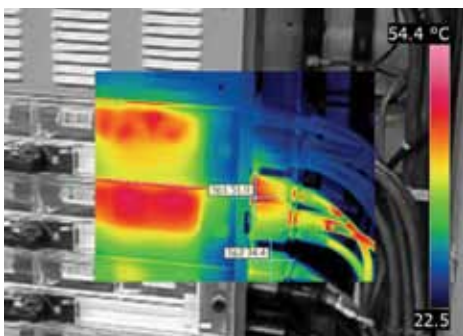
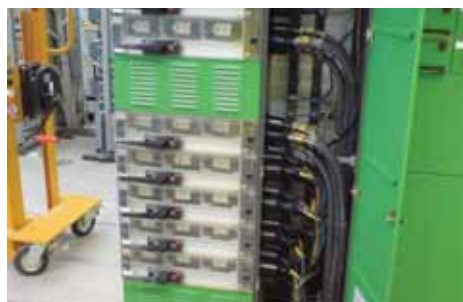
Krämer: "Especially the Picture-in-picture feature is useful to show in your report exactly where the object you're measuring is located."

To compile their reports they use FLIR Reporter Professional. "The FLIR Reporter software is very easy to use and it does the job very effectively." With FLIR Reporter you can easily create compelling and professional reports. With the new TripleFusion and Picture-in-Picture features and the latest Microsoft operating system and Word compatibility, FLIR Reporter is the most advanced thermal image reporting software currently available. "Especially the Picture-in-picture feature is useful to show in your report exactly where the object you're measuring is located."
