The Infrared image clearly shows a leak in the underground district heating network

LOCATING UNDERGROUND LEAKS

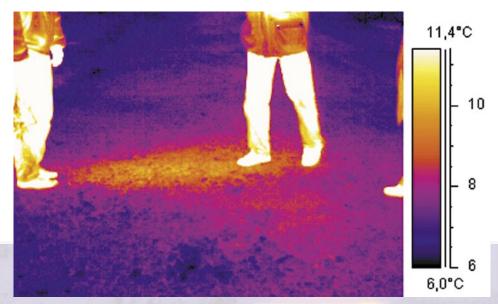
Thermal images produced by the FUIR ThermaCAM provide detailed information that is invaluable to accurately locate leaks or damages in district heating networks.

The thermal images can be used not only for fault location but also to classify and prioritize faults. The thermal camera allows even minor problems to be followed up and repair work to be scheduled as necessary.
