APPLICATION STORY

Keeping the flame burning: Infrared thermography at refineries

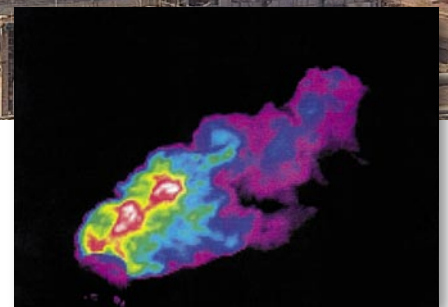
Infrared image of a flare in daylight

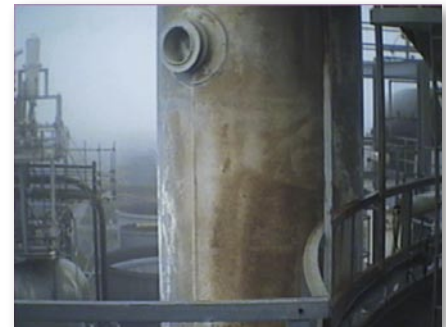
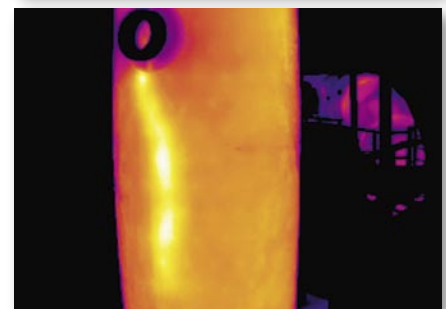
Failure in internal refractory lining

Refractory is an inner lining, consisting of high-temperature resistant materials which protect the outer shell of piping, vessels, and process furnaces from hot gases and fluids circulating inside the plant. It is vital to a safe production process: if the refractory lining fails, the steel-

made shell will quickly be weakened by heat and internal pressure. This poses a significant threat of failure of the equipment resulting in loss of containment, environmental contamination and a significant risk of fires. Many experts advise to inspect on a regular basis: "a long-term monitoring of refractory lining, based on a regular inspection every week or two weeks, leads to a detailed account of the refractory "behavior pattern" and its resistance features. This allows to manage the scheduling of planned shutdowns to renew the lining, and to avoid costly unplanned shutdowns," says Andy Whitcher. Regular observation also enables plant engineers to improve the quality of the employed refractory material.

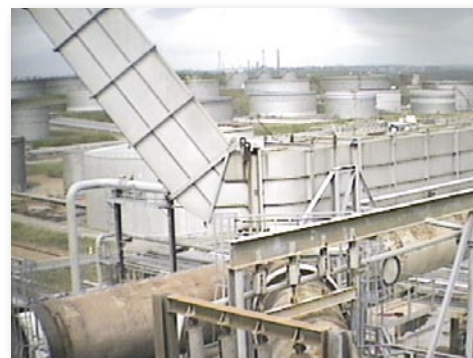
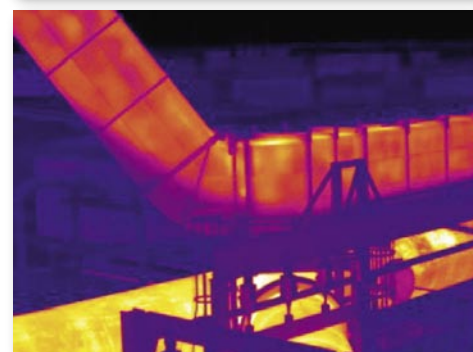
Growing buildup of deposits can be traced

Buildup of solids is a result of refractory remnants or changes in process conditions. If ash or other residues in furnaces or piping are not detected they can result in unplanned shutdowns with lengthy and expensive searches for the cause.

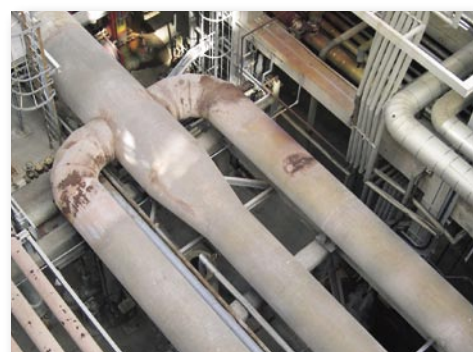
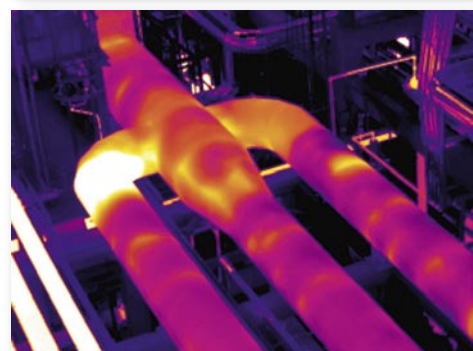
Refractory lining breakdown in an air line
