From the galley to the engine room : infrared thermography inspection of ships is gaining momentum

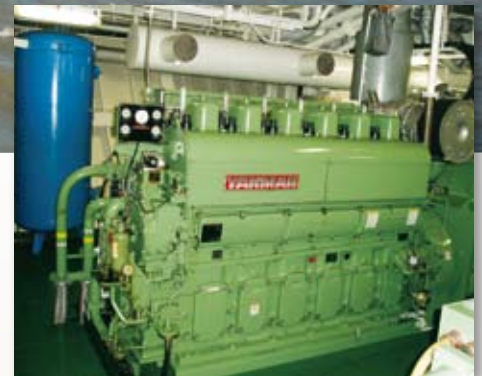
900 kW auxiliary engine

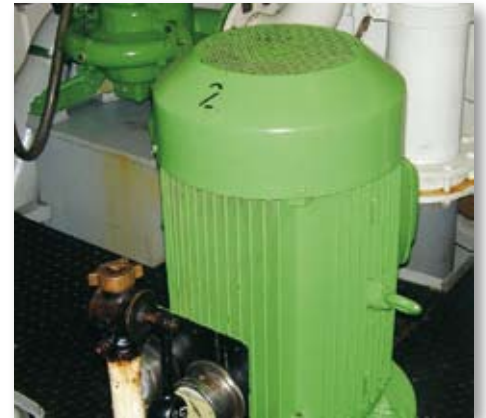
Electric engine driving a pump in a tanker engine room
