FLIR thermal imaging cameras help ensure the impeccable quality of SOLON solar modules

'Thermal imaging is a great tool both for quality control during production and for field inspections'

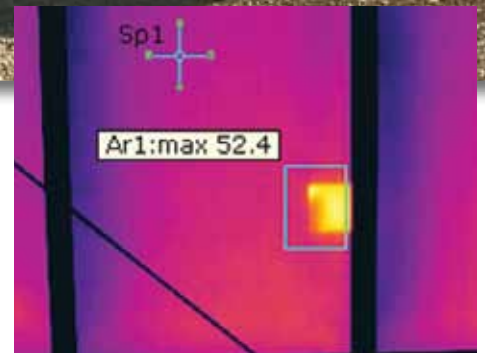
This thermal image shows a hot spot due to cell breakage in a standard 60 cell module.

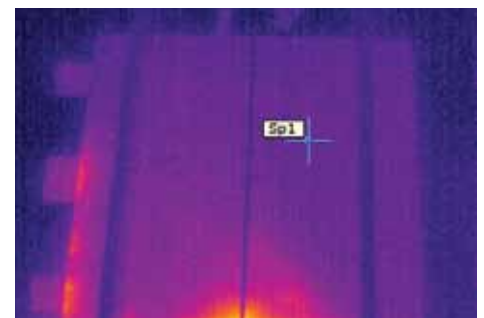
This thermal image shows that this cell has flaws in the edge isolation, which causes local shunts.

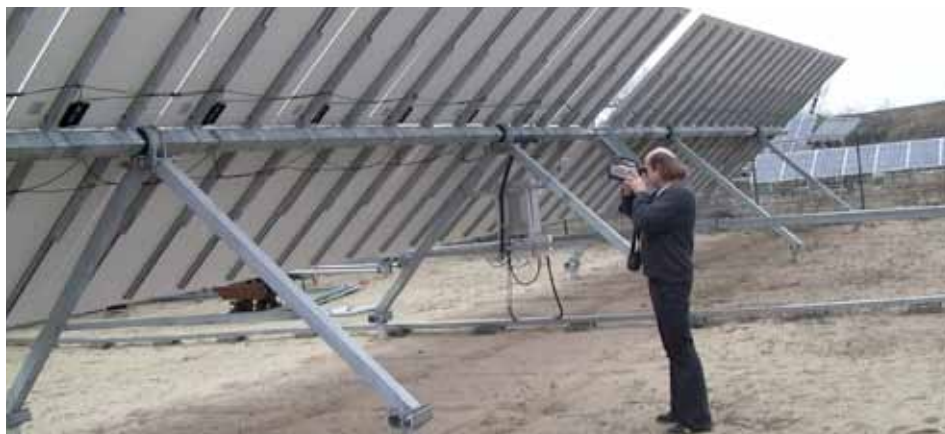
Volker Denzler, thermography expert at SOLON's after sales services department, takes thermal images from the back of a module to avoid reflections.

“Especially the tiltable lens unit is very practical”, explains Denzler. “When we’re inspecting a module in the field we usually try to look at the back, if the installation allows it. With the tiltable lens unit we can effortlessly capture the back of a solar module without having to crawl on the ground. Due to this ergonomic design feature we can effortlessly point the

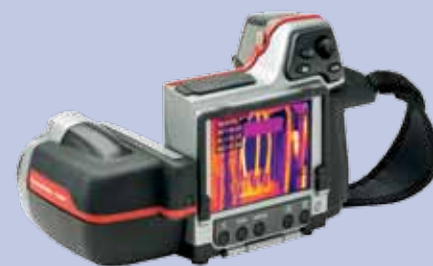
T-Series: perfect for field inspections

Developed for maintenance inspections these cameras have been designed for maximum usability. Especially the tiltable lens unit makes them very practical.

The FLIR T-Series thermal imaging cameras currently used for field inspections all contain an uncooled microbolometer detector with 320x240 pixels resolution that produce crisp thermal images at a thermal sensitivity of below 50 mK. Especially developed for maintenance inspections these cameras have been designed for maximum usability. They are compact, lightweight and ergonomically designed.

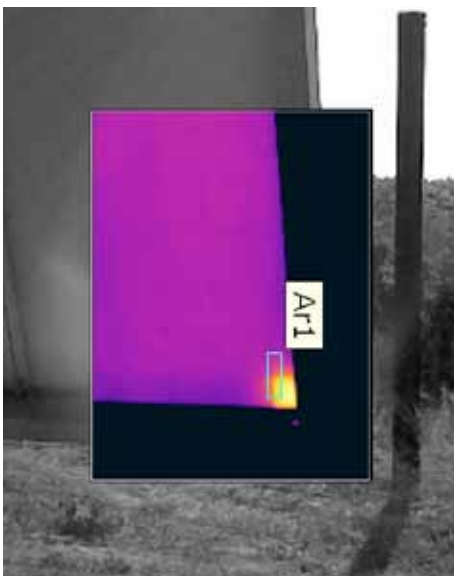
This Picture in Picture image shows a hot cell due to a shadow from the nearby alarm system.
